Arboricultural report

Sherfield on Loddon Parish Council

Sherfield on Loddon Village Green, Hook, RG27 0EE

6th of February 2024

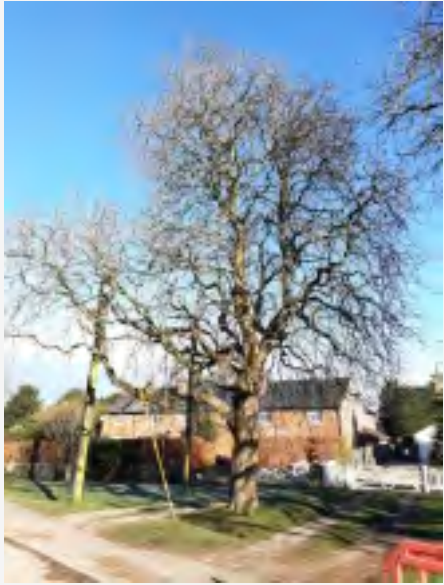
Issue	Example
<p>Compacted rooting area from vehicles and also tramping damage</p>

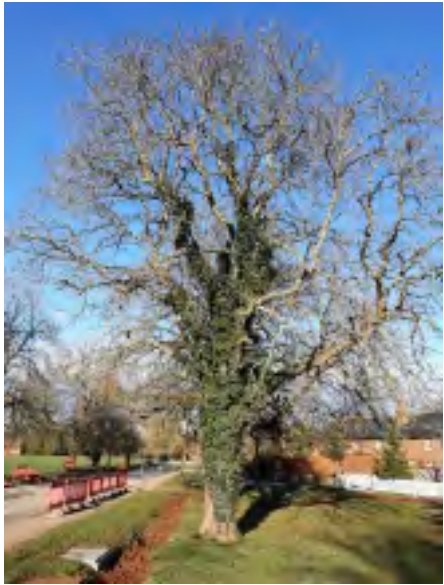
<p>Ivy clad trees limiting the tree survey and inspection currently</p>

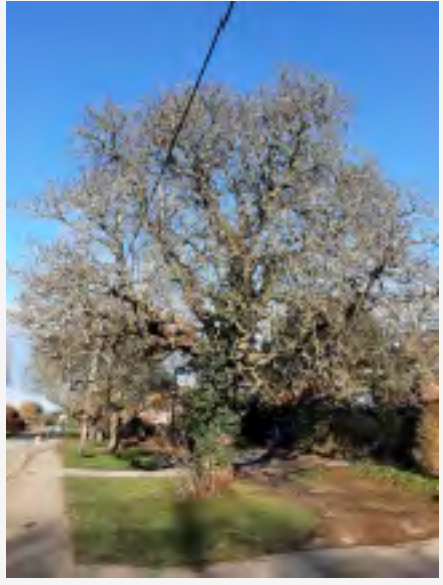
Issue	Example
<p>Overhead wires through the canopys</p>

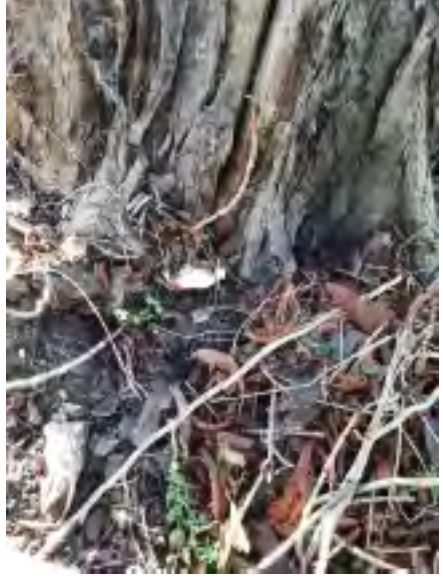
<p>Various types of fungal fruiting bodies on a range of species on the trunks, around the base and on branches</p>

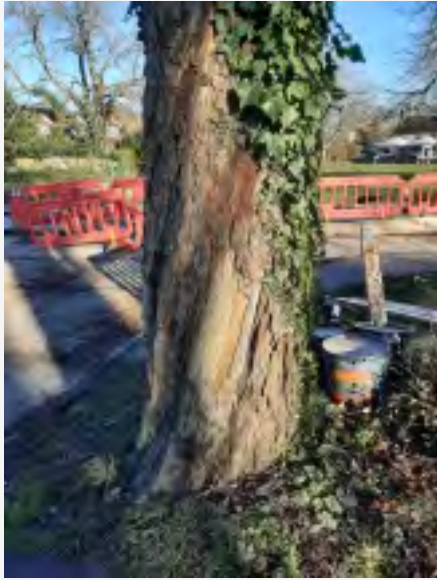
Issue	Example
Bark damage caused by various mechanical and other means

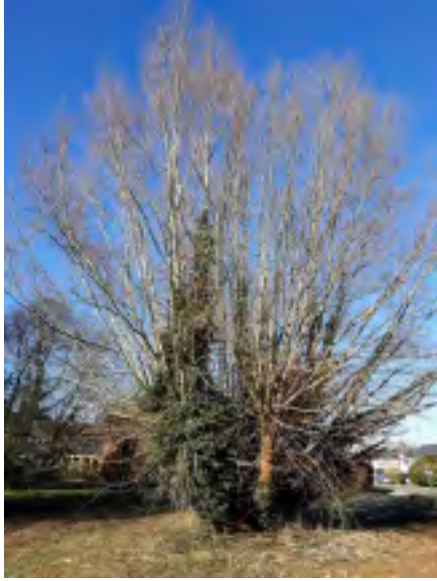
Some of the Willows have been subject to previous coppice and pollard works but in some instances, this has lapsed and now creating potential for stem failure due to the weight of the regrowth and some have started to shed branches.

Lapsed pollarding from historic and past tree works

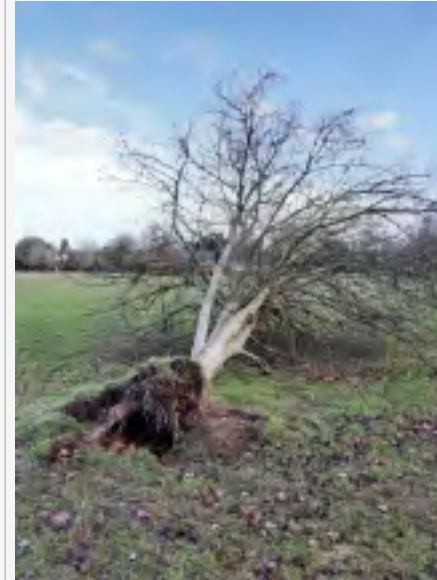
Issue	Example
Root plate failure and waterlogged ground

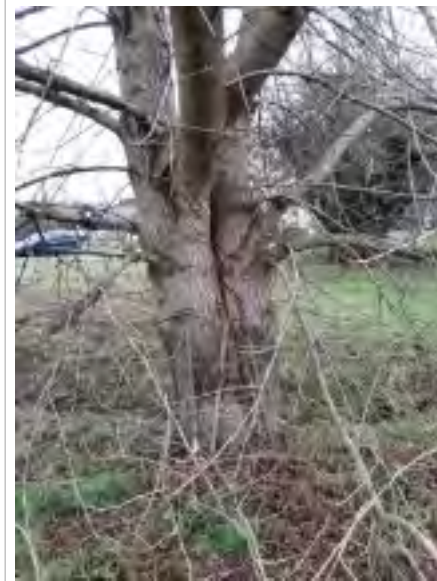
Weak forks or cracks leading to potential stem failure or trunk failure

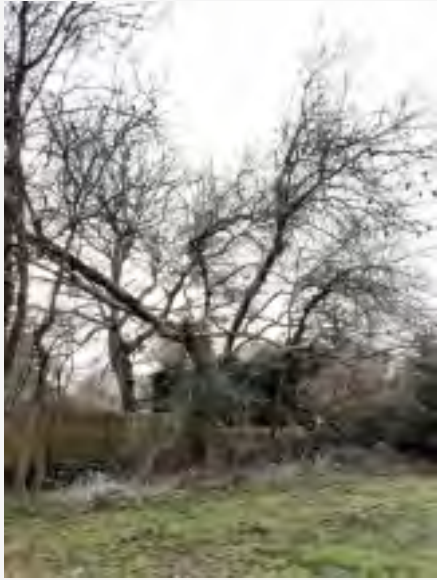
Some of the Ash have early onset Ash dieback and have symptoms of stem lesions and dieback of the branch tips. It was not possible to determine the extent of the infection without seeing the trees in full leaf though.

Issue	Example
<p>Collapsed crowns - potentially weakened as a result of Ash dieback which many of the Ash are currently showing early signs of</p>

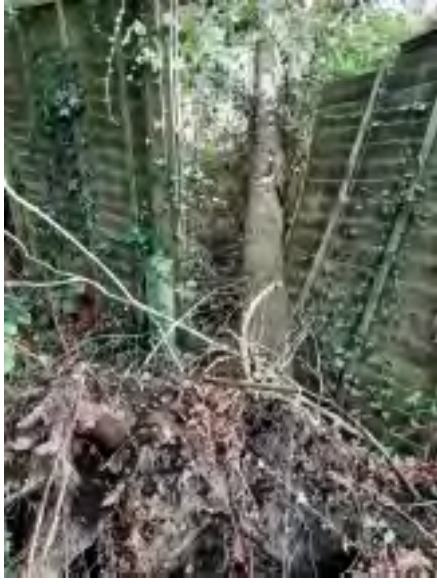
There are some young naturally regenerating Elms on the site but many are now succumbing to Dutch Elm Disease and starting to fail.

<p>Fallen trees in recent storms but potentially in this instance as a result of Dutch Elm Disease and standing dead Elms in copse behind the War Memorial</p>

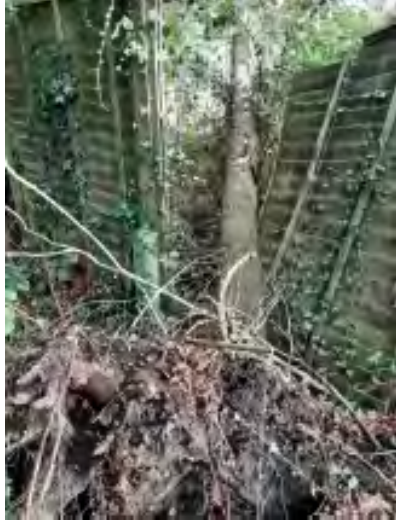
Reference	Work	Photograph
G22	· Fell Broadleaves - Fallen dead Elm through rear garden fence - clear up within 1 month reported directly to Karen Ross at time of the tree survey (x 1 tree)

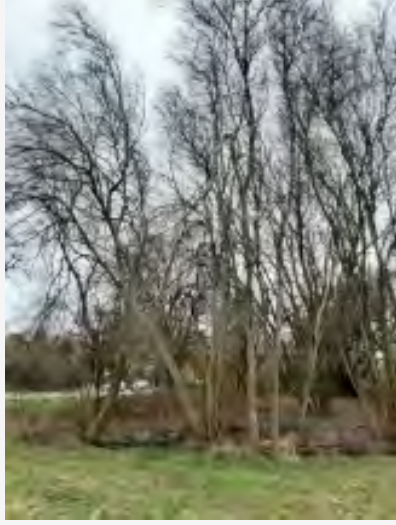
G35	· Remove hanging/broken limb - From Willow on edge of wooded Copse by tree 250 within 1 month for health and safety (x 1 tree)

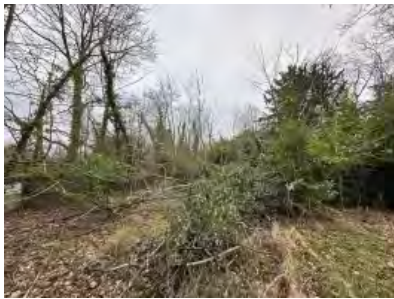
Reference	Work	Photograph
W2	<ul style="list-style-type: none"> Remove stem - Remove all fallen and leaning woodland edge trees at least 10 fallen trees breaching boundary fences on A33 and within BT compound. Prune back any overhang roadside, remove hung up trees and fell any leaning trees that lean towards the road or fences within 3 months for reasons of health and safety. (x 10 tree)

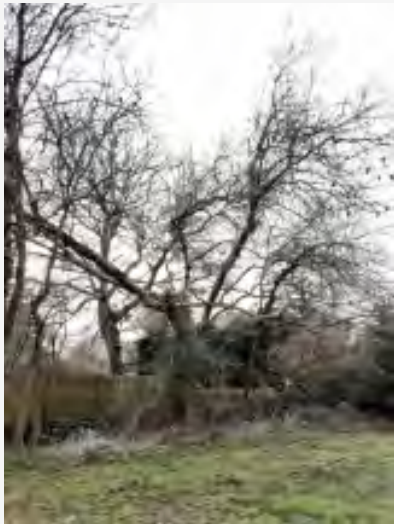
G27	<ul style="list-style-type: none"> Coppice - Ash with 6 main stems but coppice all the Ash stems in the clump plus the basal suckers within 6 months (x 1 tree) Pollard - Ash with triple trunk and failed stem in crown pollard all stems at 2 metres above ground level and remove failed limb within 3 months for reasons of health and safety (x 1 tree)

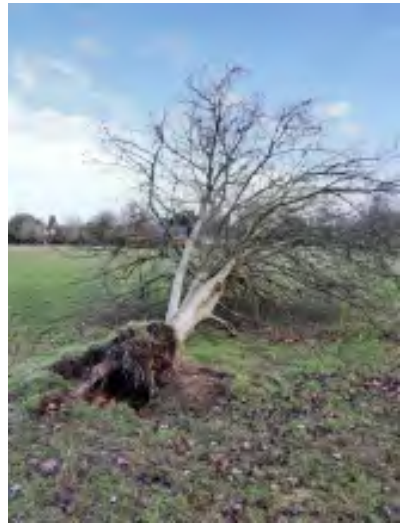
Reference	Work	Photograph
T101	Whitebeam - Clear up fallen tree within 3 months

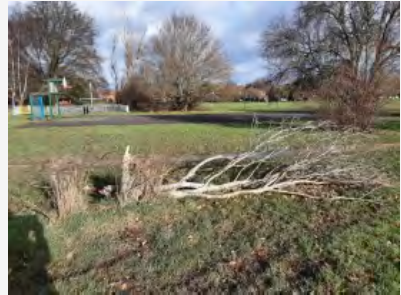
T116	Whitebeam - Clear up fallen tree within 3 months
